BATON ROUGE SSO PROGRAM
2002 CONSENT DECREE

2002 ANNUAL REPORT

January 29, 2003

Re: City of Baton Rouge and Parish of East Baton Rouge
Consent Decree-Civil Action No. 01-978-B-M3
Annual Report - **Period Ending December 31, 2002**

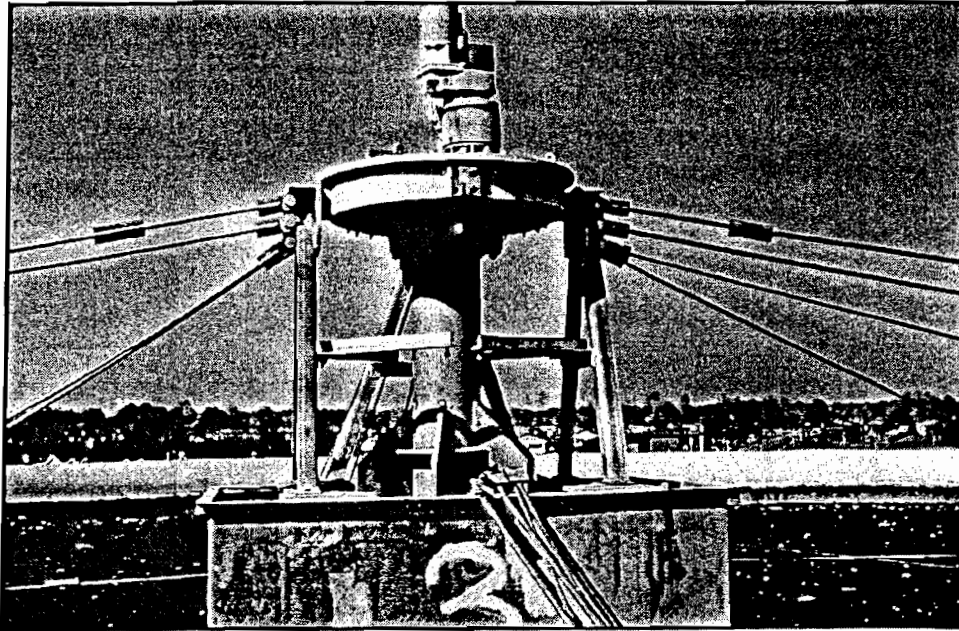
Figure 1
Photograph of one of the typical tower assemblies.

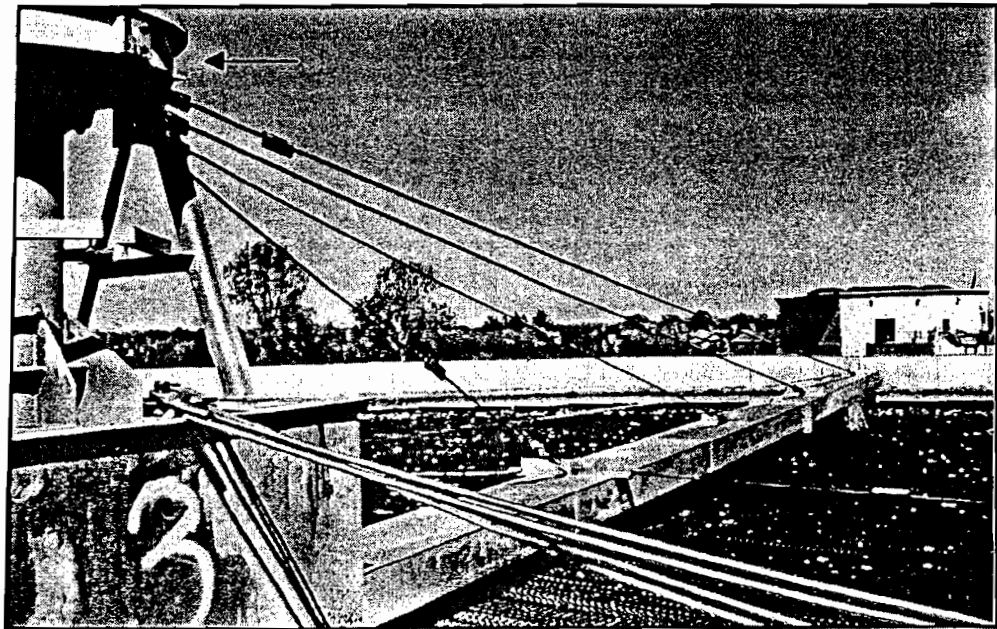
Figure 2
Another view which illustrates the mounting bracket where bolt failures are occurring.

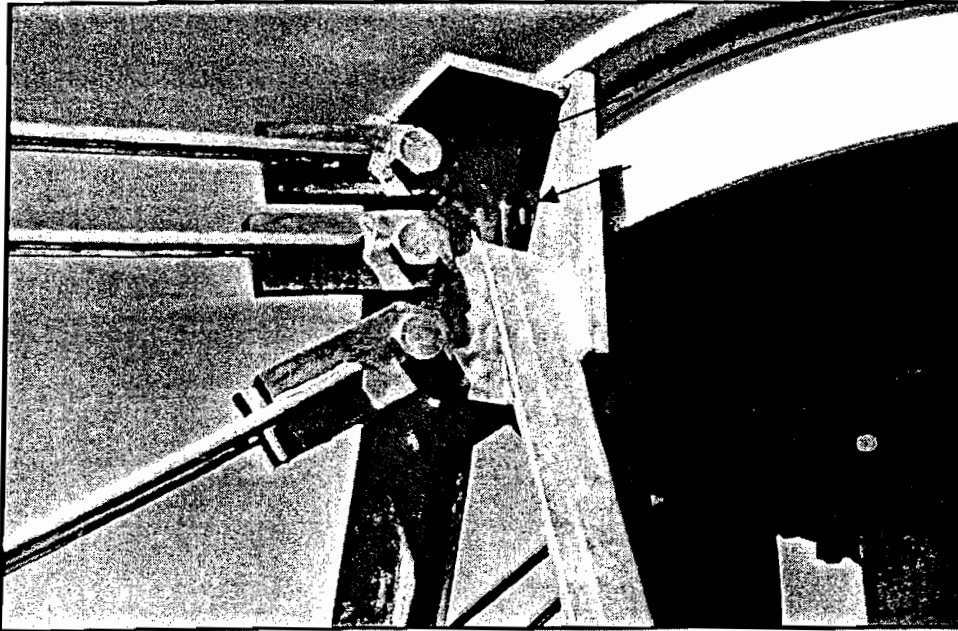
Figure 3
Closer view of a mounted bracket. Arrows show the bolts which are failing.

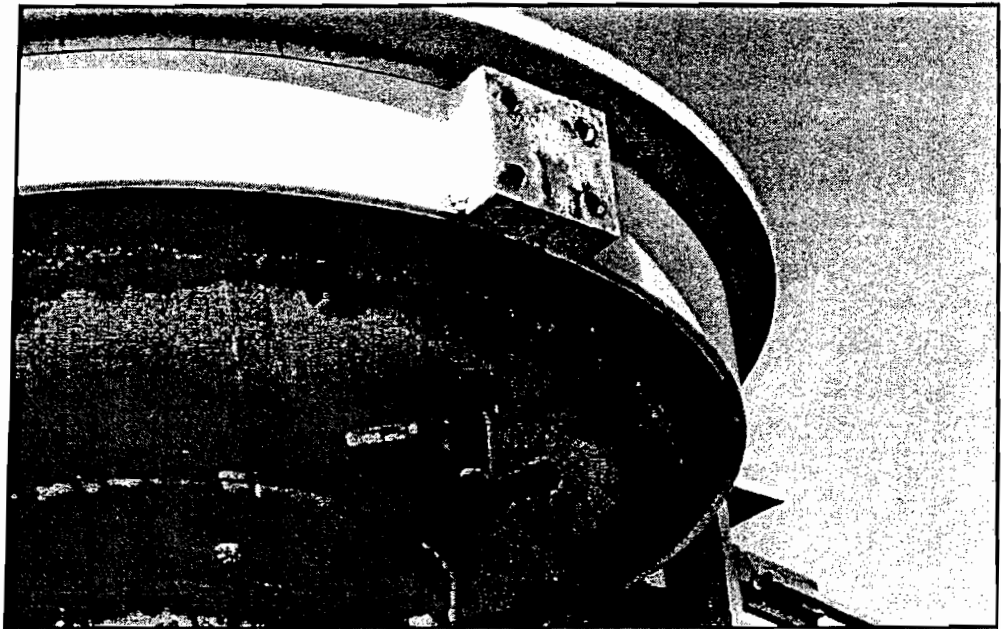
Figure 4

Closer view of the bracket which accepts the threaded bolts.

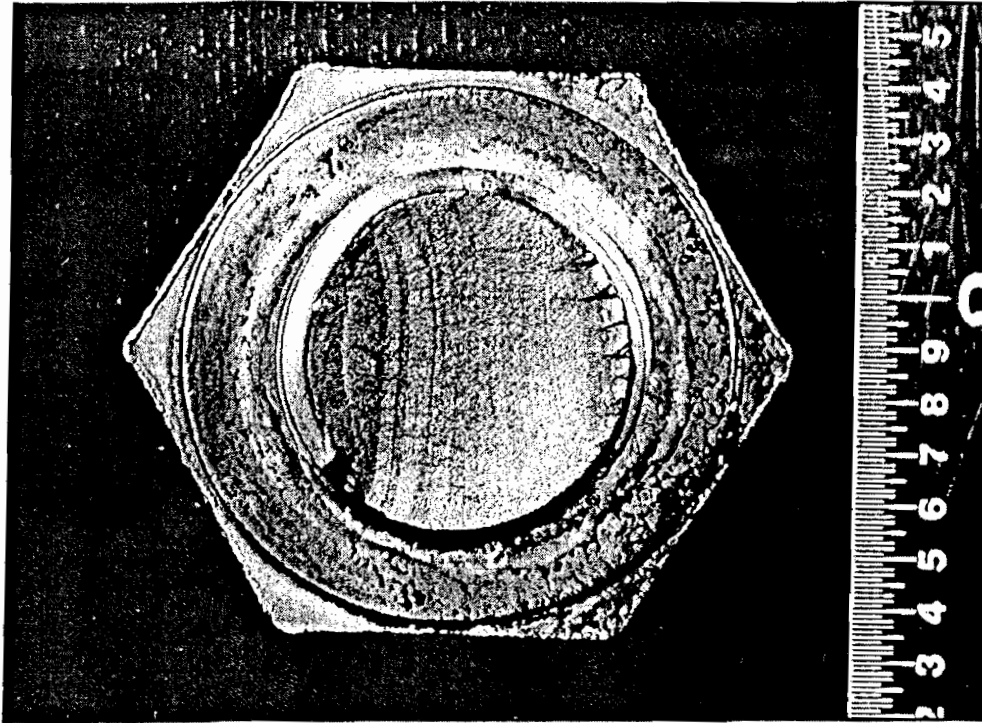
Figure 5
Photomacrograph of the head portion of the bolt fracture as-received.

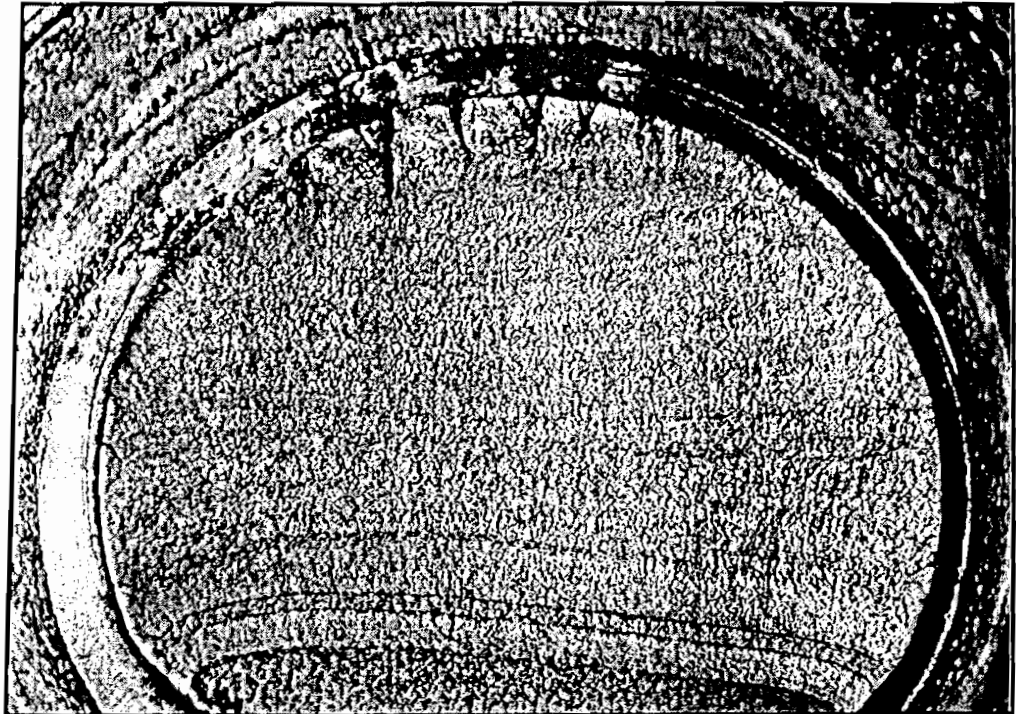
Figure 6
Closer view showing ratchet marks at top which are representative of fatigue initiation sites. Beach marks are apparent.

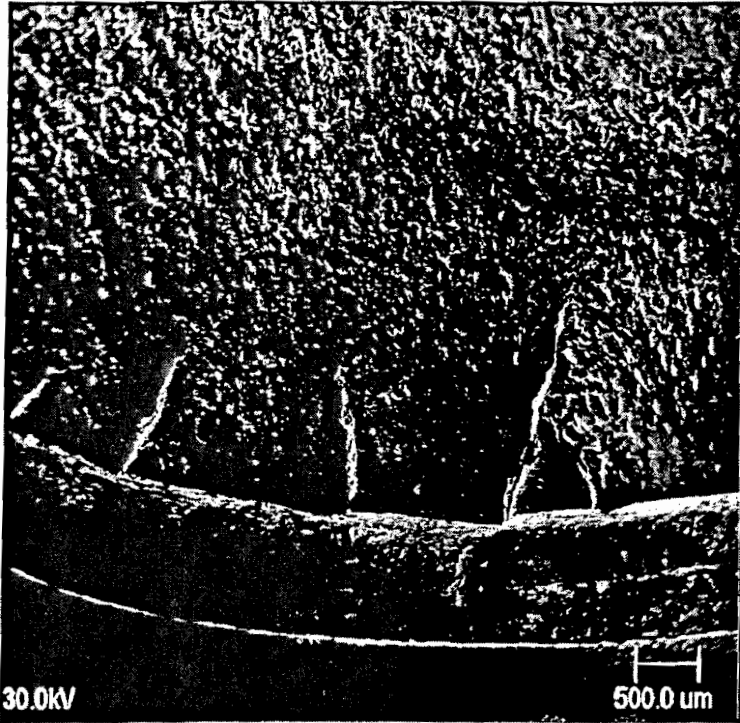
Figure 9

SEM image of the fatigue crack initiation area.

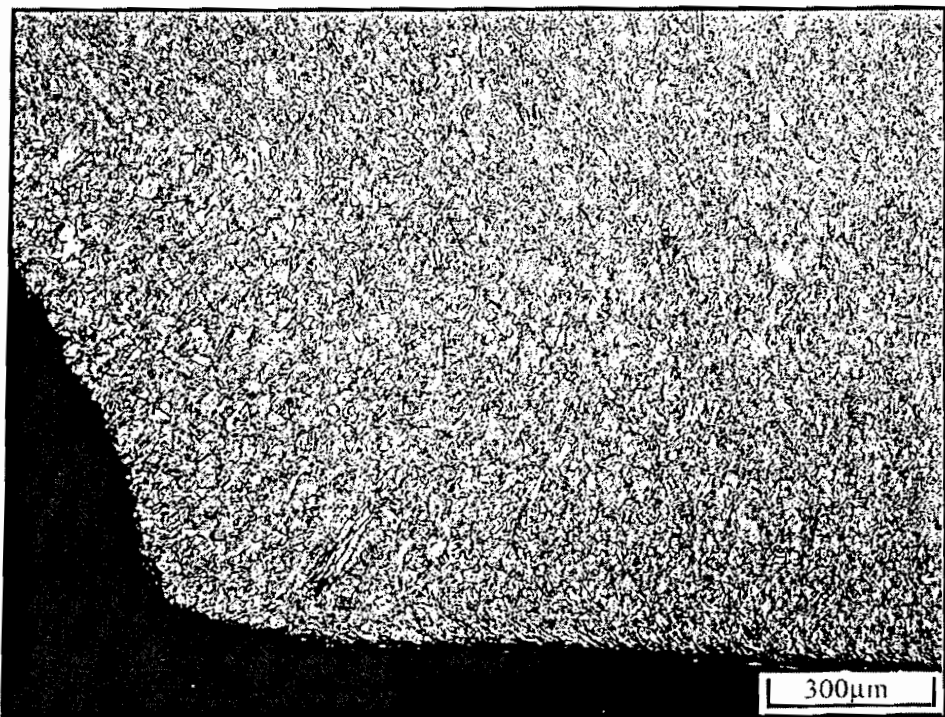
Low magnification photomicrograph of the initiation area. No anomalies observed.

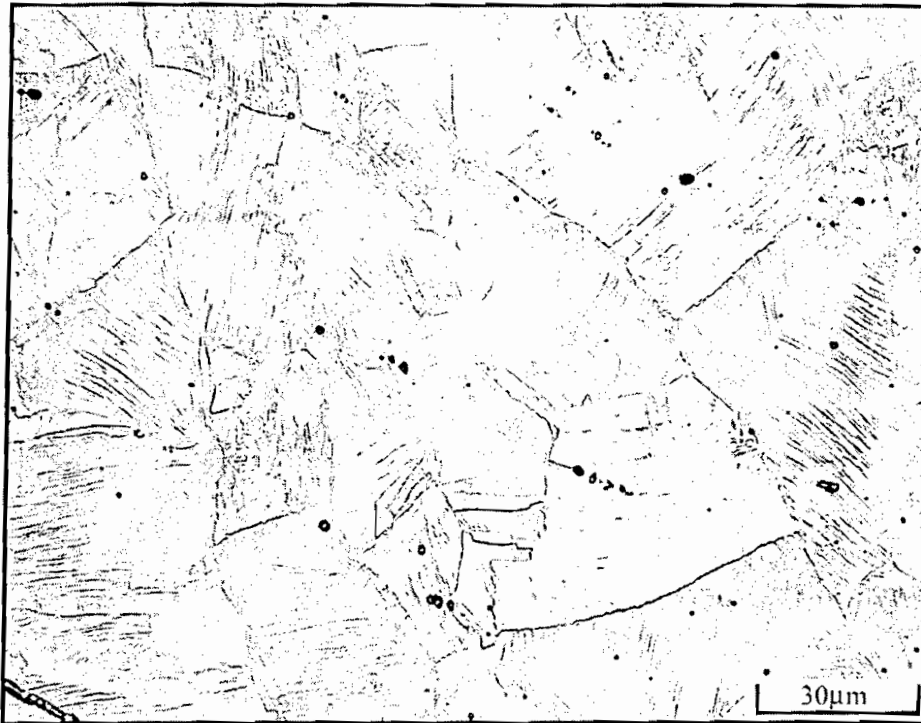
Figure 15 Etchant: Oxalic
Higher mag image of the typical microstructure showing a strain hardened condition.
