BATON ROUGE SSO PROGRAM
2002 CONSENT DECREE

2002 ANNUAL REPORT

January 29, 2003

Re: City of Baton Rouge and Parish of East Baton Rouge
Consent Decree-Civil Action No. 01-978-B-M3
Annual Report - **Period Ending December 31, 2002**

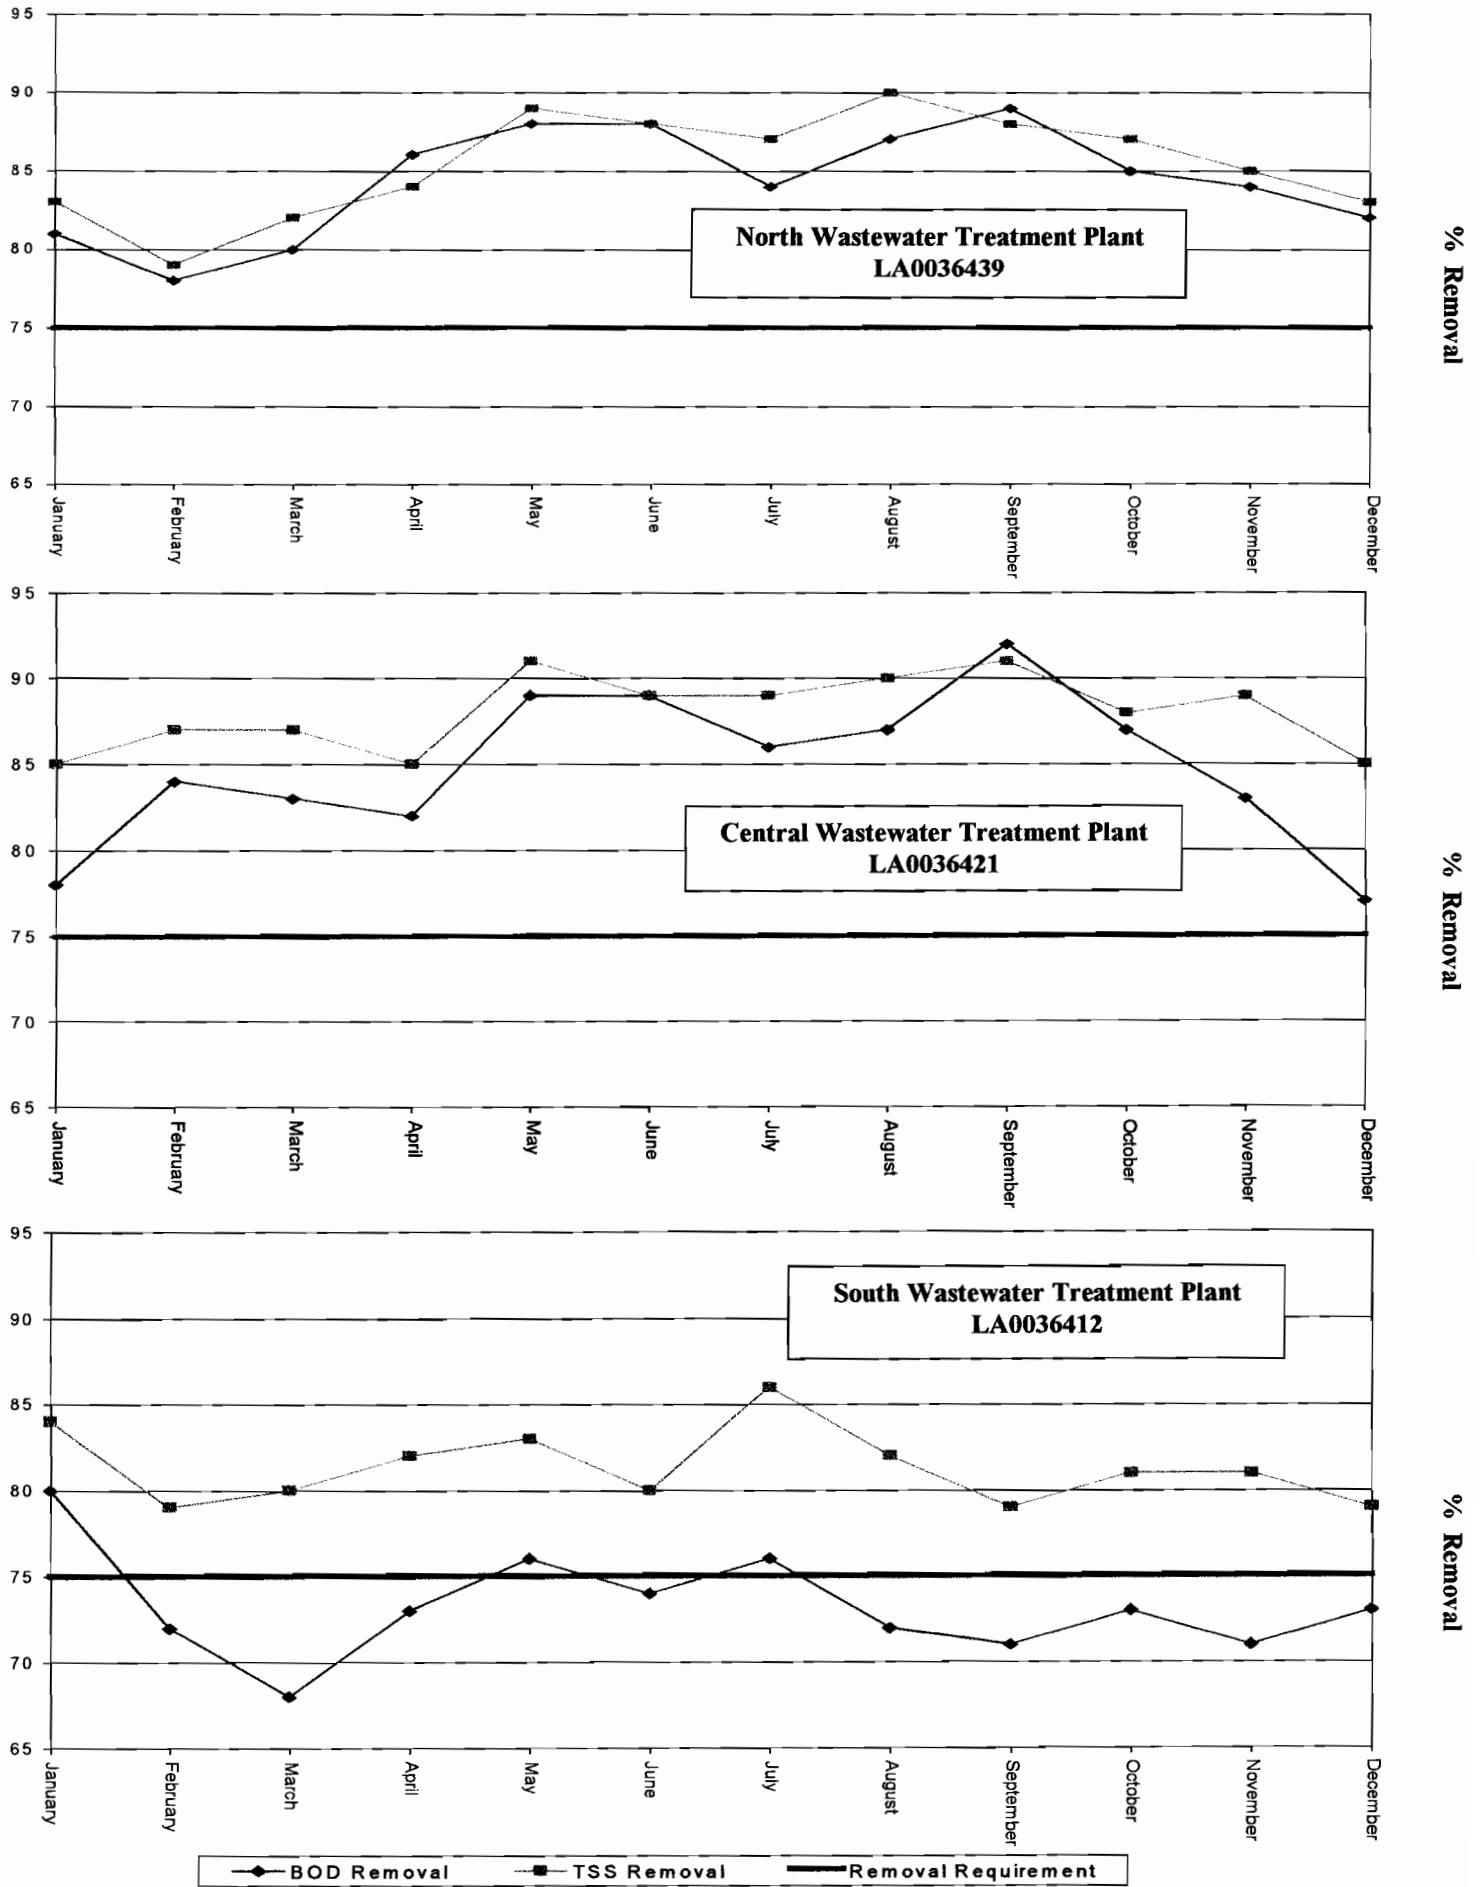
Figure 2. WWTP Monthly Average Percent Removal

Paragraph 39 of the Consent Decree provides interim effluent limits of 75% removal of BOD and TSS (based on 30-day average removal rates), until completion of all RMAP construction projects, as an interim relief to the 85% removal requirement of the three WWTP NPDES permits. During 2002 the North and Central WWTPs have been in compliance with the 75% interim effluent limits. In fact, 50% of the time, both treatment plants met the permit limit of 85% removal of BOD, and more than 50% of the time they met the permit 85% removal limit for TSS, as illustrated by Table 5 and Figure 2.

The South WWTP has been in compliance with the 75% interim effluent limit for TSS all year, but has not met the 75% interim effluent limit for BOD for 9 months of the year. The South WWTP has been experiencing operational difficulties related to snail infestation and failure of four trickling filter distributor arms, as documented in Appendix D. We have ordered snail screening collection equipment for the South WWTP (similar to equipment installed at the Central WWTP), and will be taking construction bids for replacement of the trickling filter distributor arms in January 2003. We anticipate the treatment plant will be operating within interim effluent limits by August of 2003.

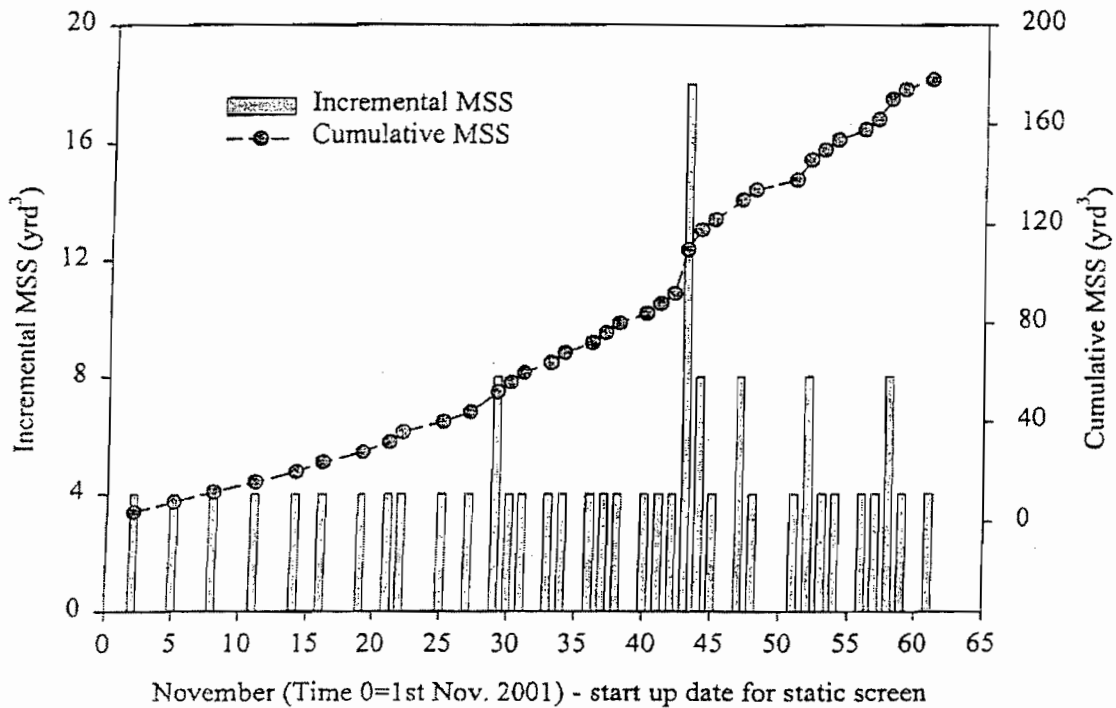
Snail/Biomass Recovery as MSS (Metz suspended snails) at CTP

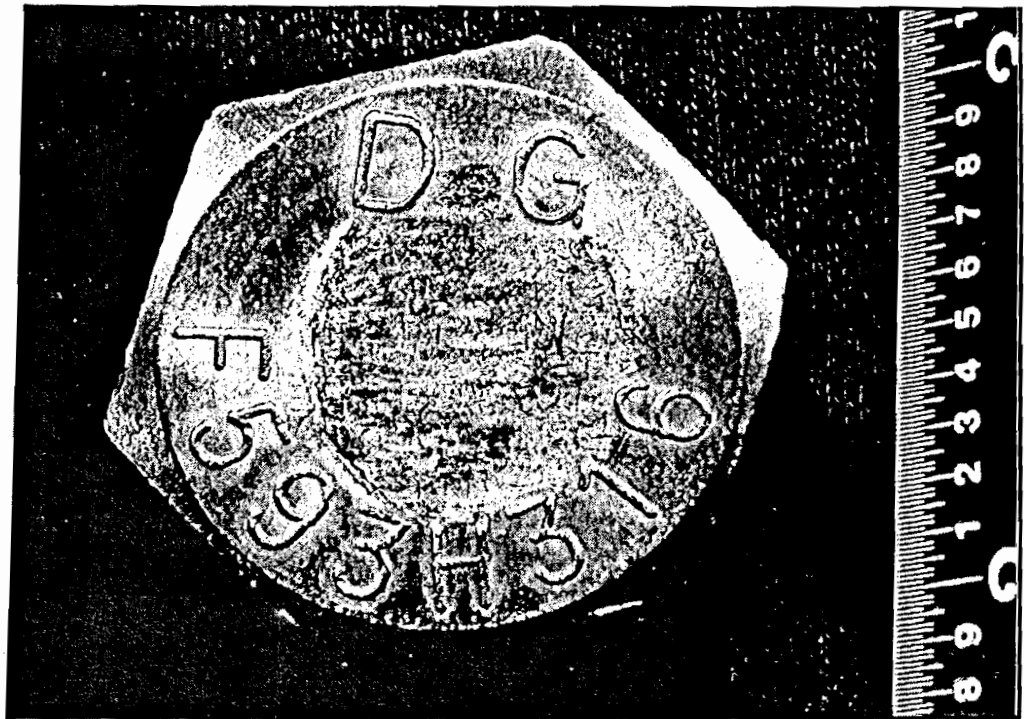
Figure 8

Markings on the backside of the bolt indicate the material is 316 stainless steel (figure 8).

Markings on the
bolt head.

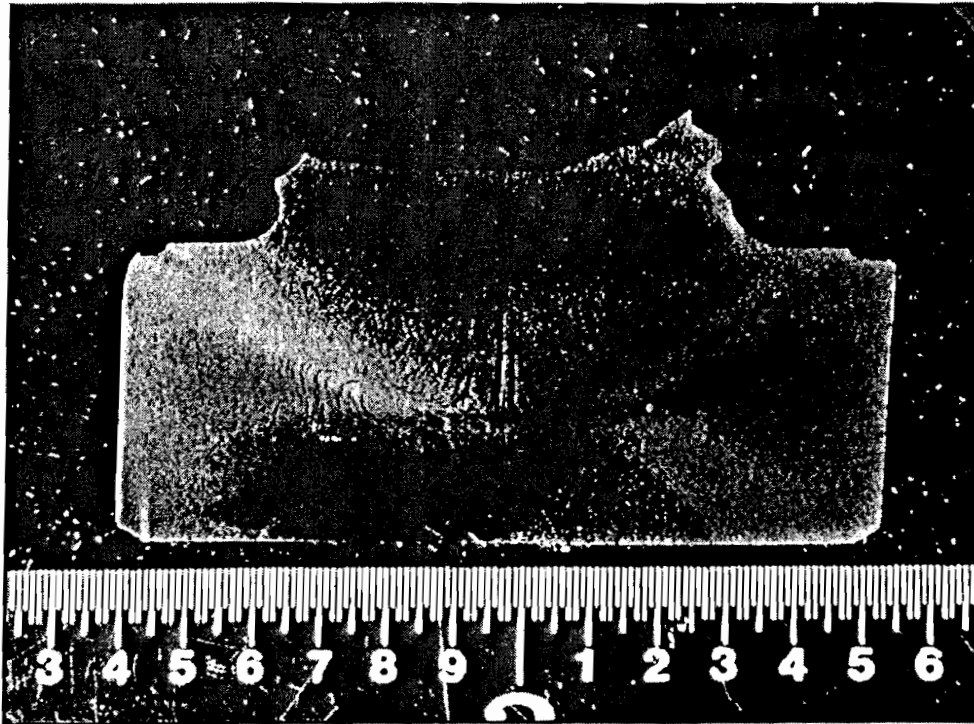
A cross section was removed through the bolt head and metallographically prepared. The section was made such that it would incorporate the origin of the fracture. Figure 13 provides a photomicrograph of the section after etching in an appropriate reagent. Macroscopic flow lines suggested the bolt head was manufactured by likely an upset forging technique. No anomalies were observed macroscopically.

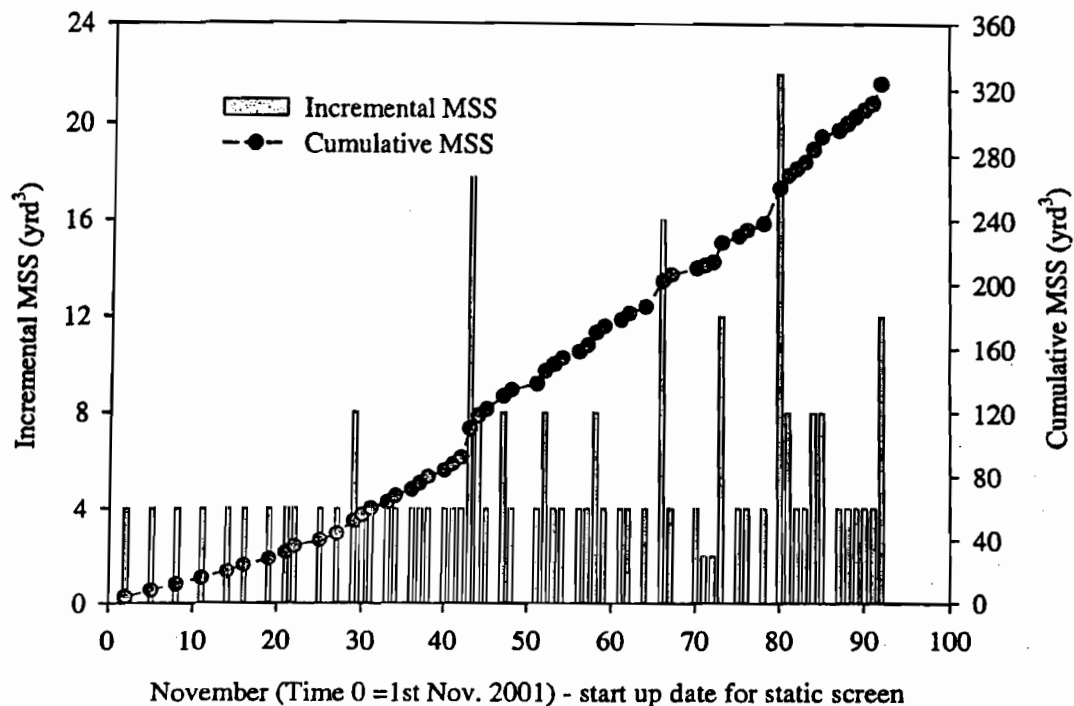
However, snail infestation proved to have no adverse effect on the treatment performance of trickling filters and BOD₅ conversion across the entire plant. Objectives of recirculation were to improve treatment stability, generate sufficient flow to trickling filters and to control snail populations through hydraulic flushing. Through automated recirculation of trickling filter effluent to the top of the trickling filters, CTP has reduced effluent total BOD₅ from a mean of 28.4-mg/L in 1999 to a mean of 23-mg/L in 2000. Starting in March 2000, CTP began to regulate the recirculation with scheduled flushing. Total organic loading at CTP was 7 kg BOD₅/m³·hr. The SK value for flushing was 992. A recirculating flow model was developed to examine stability across the plant. Of the variable studied, inflow had the highest correlation to the recirculating flow to the trickling filters and the primary factor that influences recirculation. Recirculating valve position and pump speed is proportional to the recirculating flow.

Figure 3. Snail/biomass recovery as MSS (Metz suspended snails) at CTP. Incremental spikes above the 4-yr³ increment level are due to wet weather loadings at CTP. Dry weather control of snails in two trickling filters is implemented through controlled recirculation of trickling filter effluent.

Current status (November 2002): Currently, recirculating flow is used to promote biomass growth and control; and is augmented with static straining screens to control snails as a nuisance at CTP. The static screens at CTP are reducing the inventory of snail-based sludge material so this material does not make it to the digesters. In addition the static screens are capturing the continual influx of snails especially during wet weather flows. One trickling filter has been removed from operation at CTP and the plant has excellent stability due to continuous operation of two trickling filters and recirculation. Both recirculation and static straining screens have been recommended for STP and are in planning stages. Static screen location recommendations have been made and recirculation configuration recommendations have been made. Both static screens and recirculation are critical for STP, in particular, controlled recirculation of trickling filter effluent.
